Degradation Processes in High Power Multi-Mode InGaAs Strained Quantum Well Lasers

Yongkun Sin*, Nathan Presser, Brendan Foran, and Steven C. Moss
Electronics and Photonics Laboratory
The Aerospace Corporation
El Segundo, CA 90245-4691

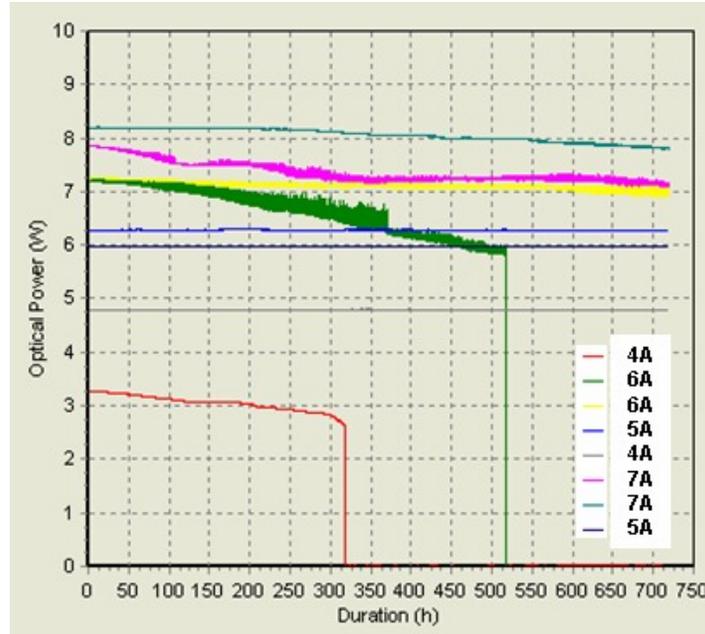
Figure 1. Accelerated lifetest result.

Lifetests A commercial laser reliability tester was employed to introduce failures to all the laser diodes studied. Test conditions used for unpassivated devices were stress currents of 4 and 5A at a base-plate temperature of 65°C, whereas test conditions for passivated devices were stress currents of 4, 5, 6, and 7A at the same base-plate temperature of 65°C. Typical test duration of each accelerated lifetest was 720 hours. A series of accelerated lifetests were performed under automatic current control (ACC) mode and one of lifetest results is shown in Figure 1.

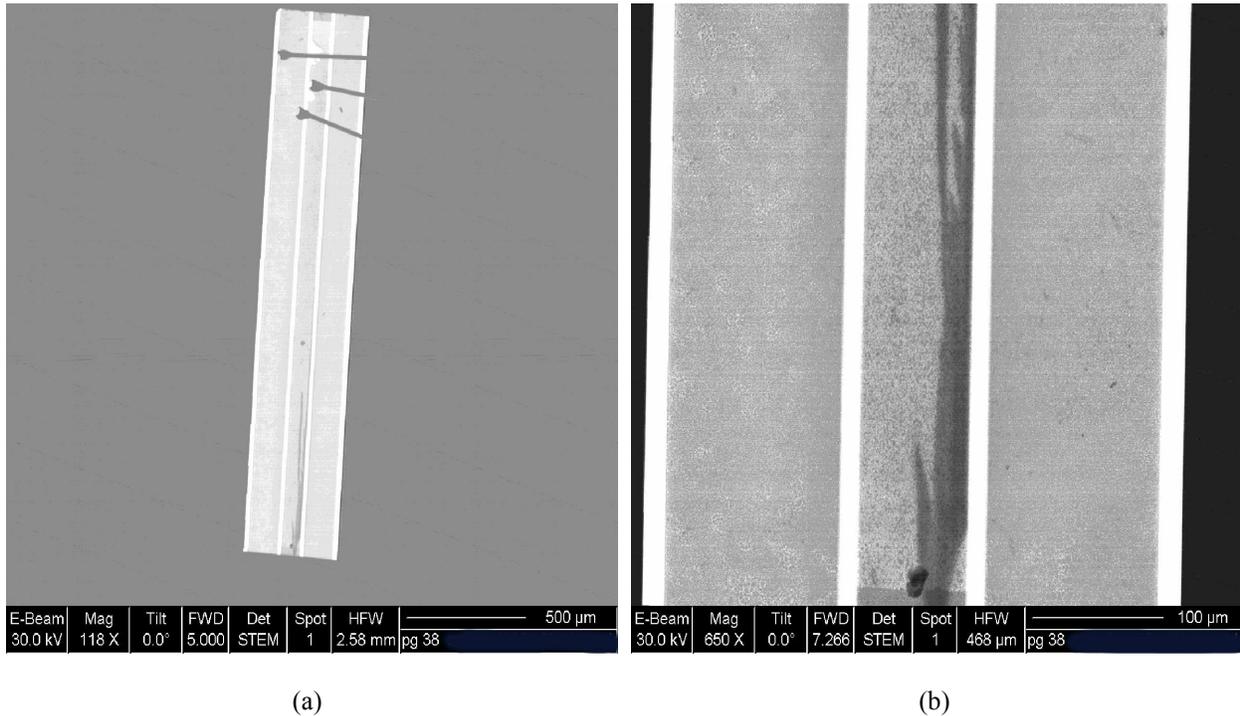
Figure 2. EBIC images from Sample A. EBIC images showing the whole chip (a) and front facet area (b) of Sample A.

Figure 2 shows EBIC images showing the entire chip (a) and front facet area (b) of Sample A, which was lifetested at 5A and a baseplate temperature of 65°C. This sample showed an ~50% drop in optical power. DLDs of Sample A originated from the front facet, indicating that this sample failed by COMD. Figure 3 (a) and (c) shows EBIC images from Sample B and Figure 3 (d) shows an EBIC image from Sample C. Both samples were electrically overstressed at 7A and the baseplate temperature of 25°C to intentionally increase optical power density at the front facet above a threshold for COMD. Both samples showed significant amounts of drop in optical output power. Sample B showed a ~85% drop, whereas Sample C showed a ~95% drop. DLDs of Sample B and Sample C (DLDs of Sample C not shown here) impacted the front facet, consistent with the observation of COMD. Significant heating at the front facet created a blister for both samples. Figure 3 (b) is a SEM image of Sample B showing a ~1 μm long blister sticking out from the front facet as a result of a significant temperature rise of over 1000°C at the localized spot. Figure 3 (c) and 3 (d) are EBIC images from Sample B and Sample C, respectively. These images show the front facets of both samples where active layers were glowing except at the blister area and clearly indicate that the p-n junction interface surrounding the hot spot or blister was significantly displaced during the COMD process. The formation of DLDs in degraded InGaAs-AlGaAs strained QW lasers with a significant drop in optical power is due to the growth of dislocations. Dark lines or dark areas observed from the active region indicate the presence of localized defects in the active region.

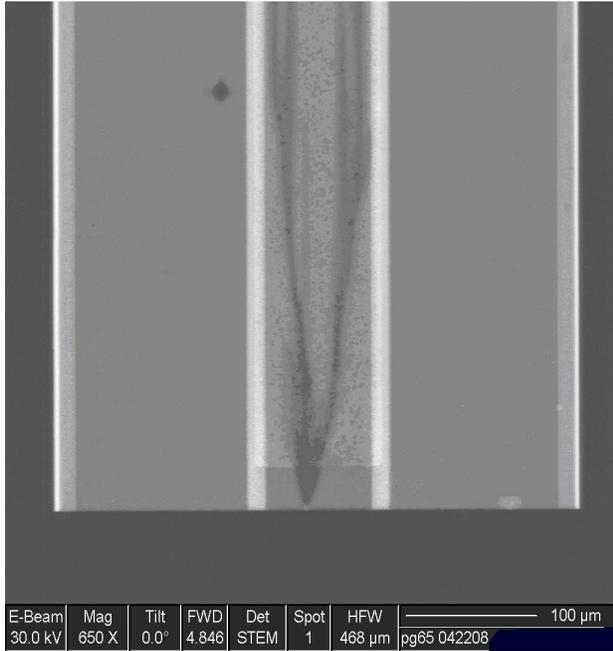
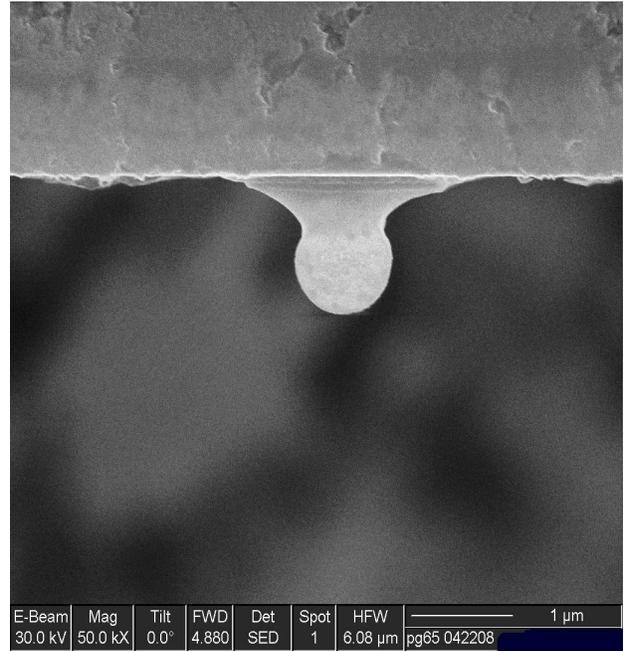
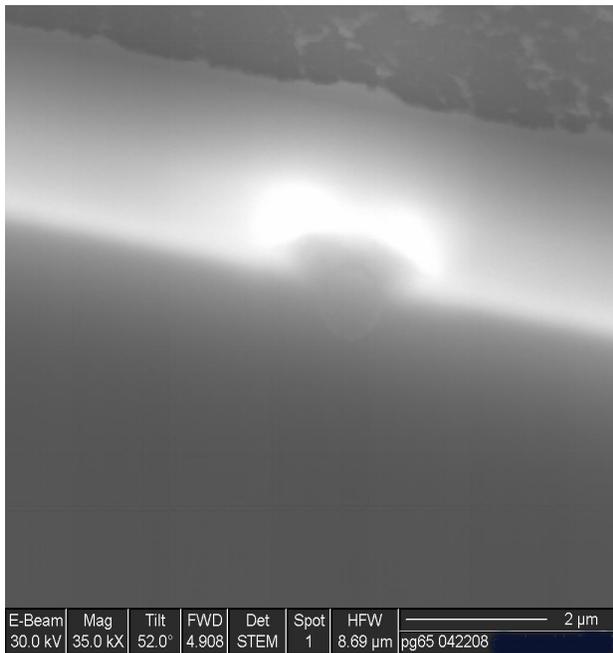
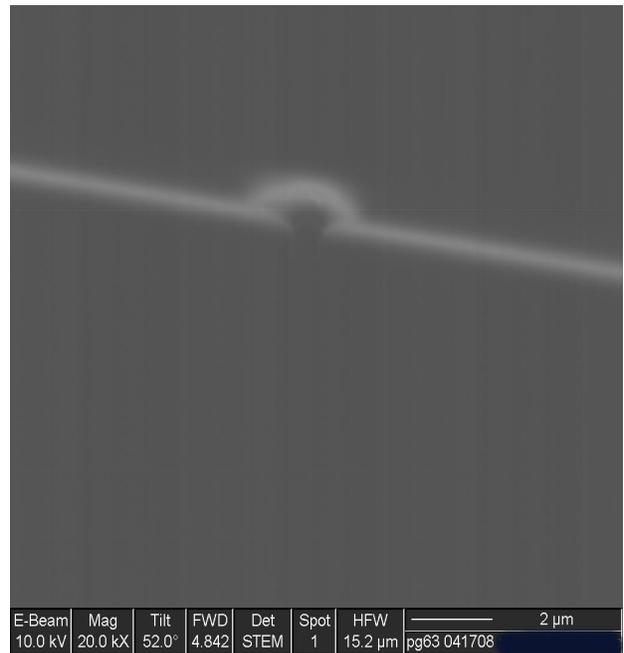
Figure 3. EBIC images from Sample B (a, c) and Sample C (d). SEM image of Sample B (b).

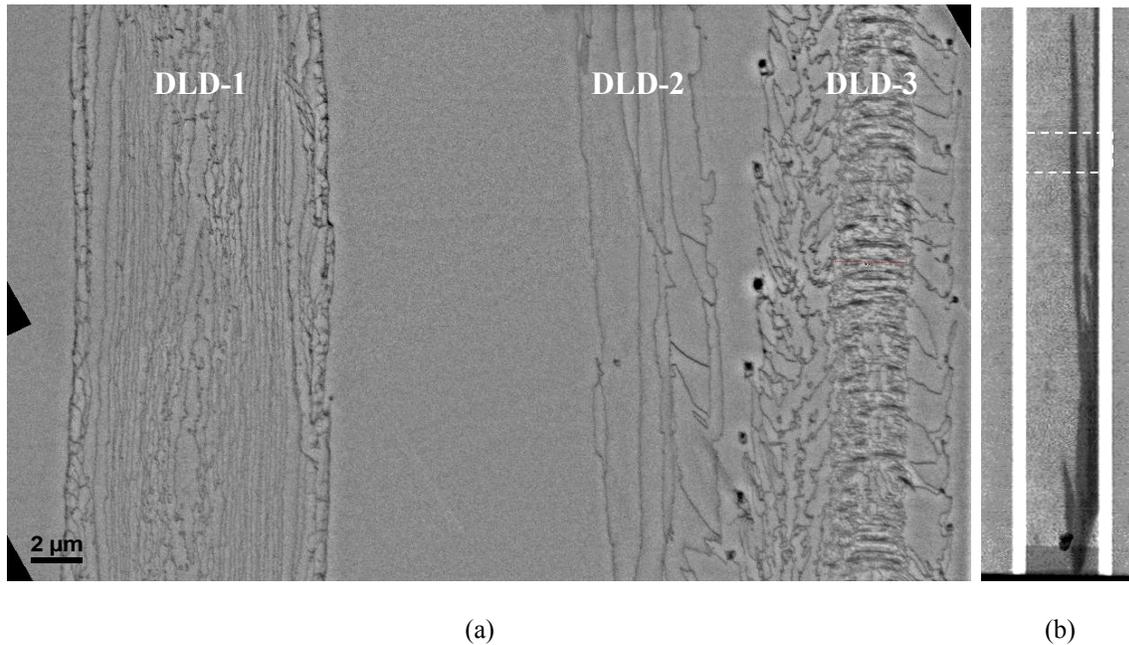
Figure 4. Plan view TEM image from Sample A (a) and EBIC image from Sample A showing the location of TEM sample indicated as a dotted area (b).

We also studied broad-area lasers with a 5-10% drop in optical power and no obvious DLDs were observed from these samples. Two types of DLDs have been reported including (100) DLDs and (110) DLDs. (100) DLDs are due to dislocation networks formed by climb motion of pre-existing dislocations, whereas (110) DLDs are due to dislocation networks formed by glide motion of dislocations. Only (110) DLDs were observed from our samples failed by the COMD process. To understand failure mechanisms responsible for catastrophic facet degradation of broad-area lasers, a series of TEM samples were prepared using focused ion beam analysis from laser diode samples failed by COMD. Figure 4 shows a plan view TEM image from Sample A. The EBIC image of this sample is shown in Figure 4 (b), where the location of the TEM sample is indicated as a dotted area. The plan view TEM sample covering an area of $\sim 10\mu\text{m} \times 20\mu\text{m}$ was located $\sim 500\mu\text{m}$ away from the front facet and enclosed three distinctive dark lines. The TEM image clearly shows a high density of dislocations along all three dark lines and the width and separation of three dislocation areas coincided well with those of the dark lines observed from the EBIC image. Detailed defect analysis is necessary to fully understand the very different defect structures observed from the three DLD areas, but it appears that filamentary behavior of the optical beam might be responsible for DLD-3.

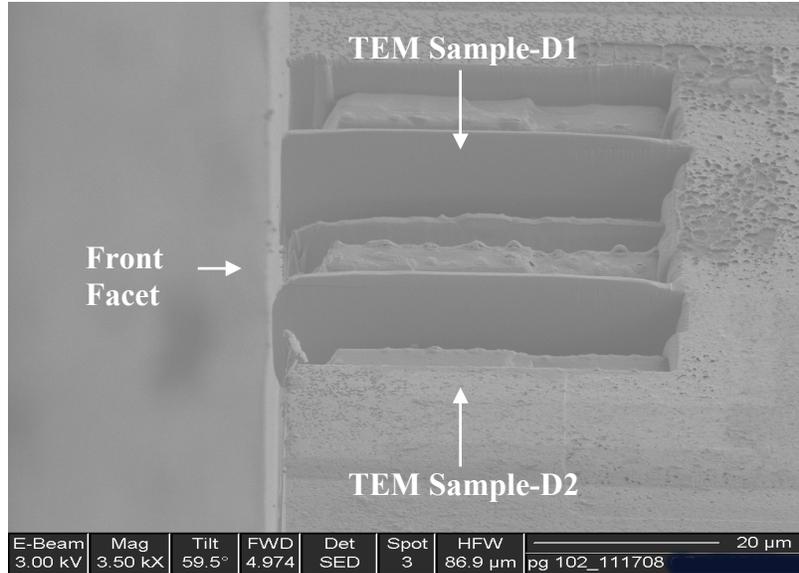
Figure 5. SEM image of Sample D showing the location of two cross sectional TEM samples.

Figure 5 shows a SEM image of Sample D, where two TEM samples were prepared. One TEM sample, TEM Sample-D1, was from the DLD area, whereas the other TEM sample, TEM Sample-D2, was not. Both TEM samples were $\sim 20\mu\text{m}$ long and included the front facet. Figure 6 shows cross sectional TEM images from TEM Sample-D1. This sample shows extensive damage introduced to the InGaAs QW and surrounding the SCH layers. TEM Sample-D2 prepared from areas outside of the dark line showed no dislocations.

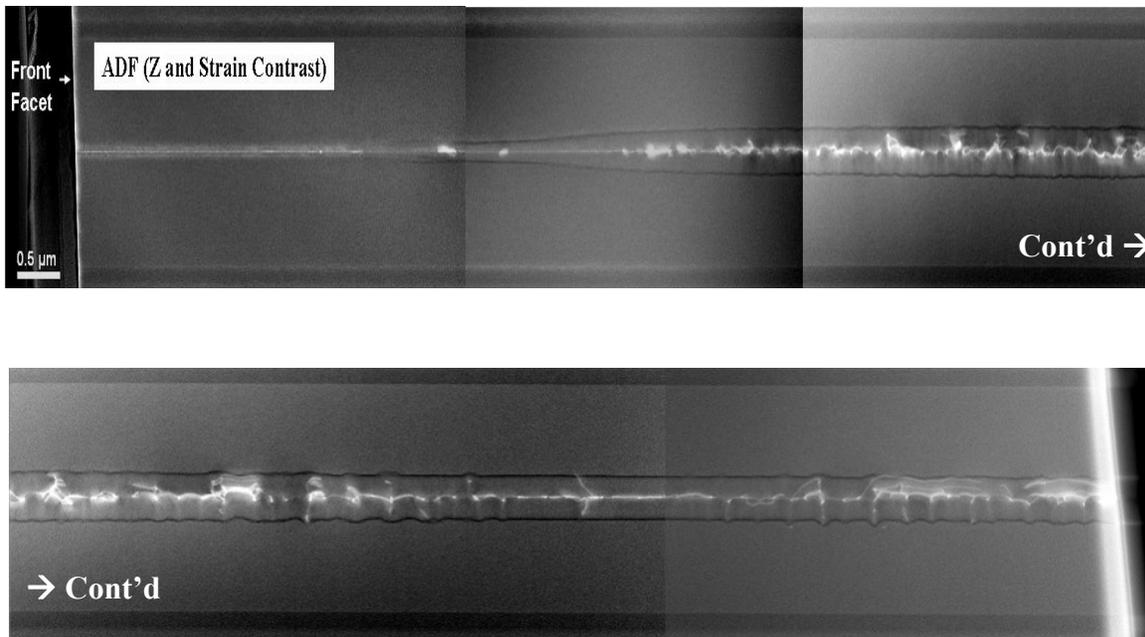
Figure 6. Cross-sectional TEM images of TEM Sample-D1.

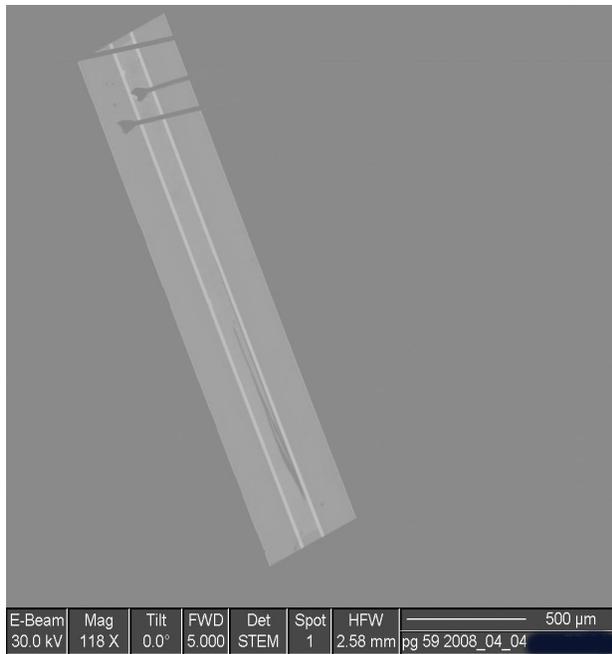
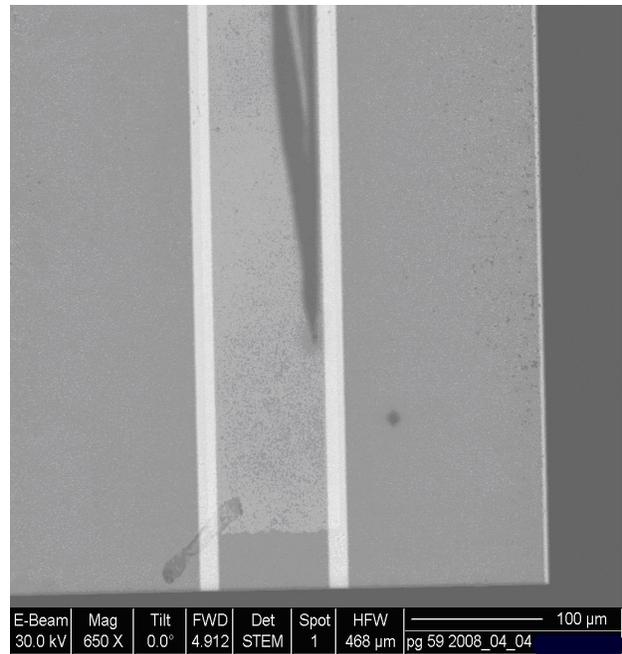
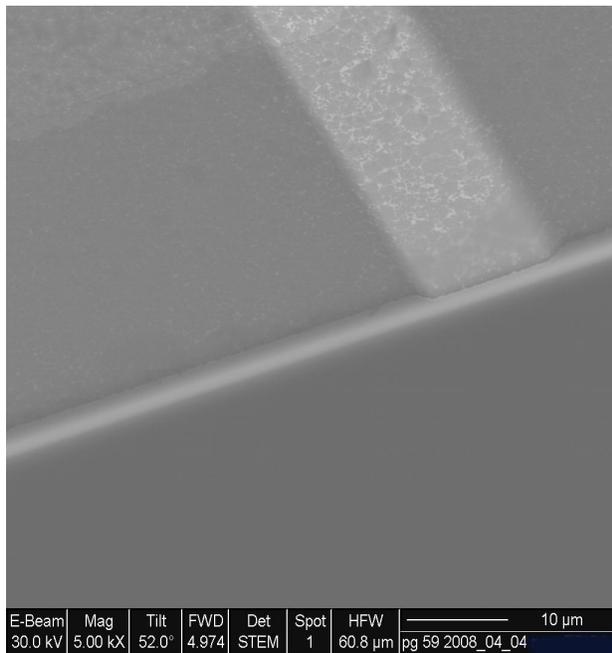
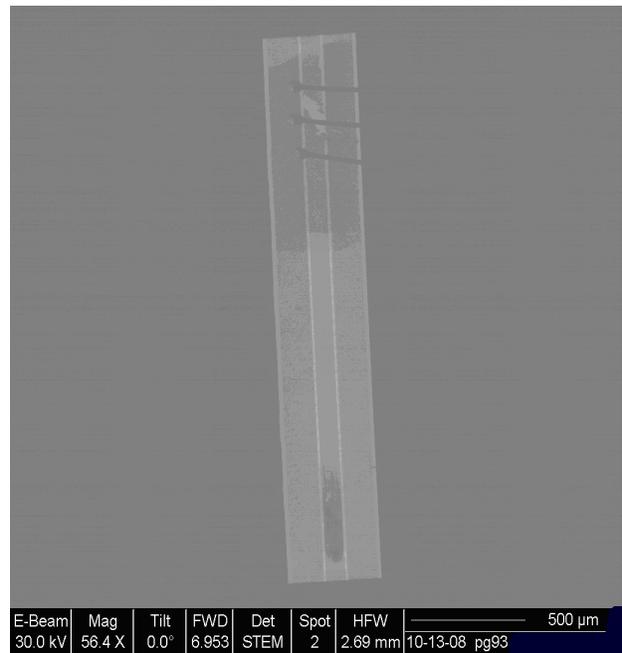
Figure 7. EBIC images from Sample E (a, b, c) and Sample F (d). EBIC images showing the whole chip (a), area near front facet (b), and front facet (c) of Sample E.

Figure 7 shows EBIC images from Sample E and Sample F. Sample E and Sample F were lifetested at 5A and 6A, respectively at the same baseplate temperature of 65°C . Figure 7 shows EBIC images from the whole chip (a) and front facet area (b) of Sample E as well as the EBIC image from Sample F (d). Figure 7 (c) is the EBIC image from the front facet of Sample E near the edge of the waveguide showing a glowing active layer confirming no facet damage introduced to the sample. Two observations that no DLDs were observed near the front facet for Sample E and Sample F and that DLDs of these two samples originated from the inside of the cavity indicate that these samples degraded by bulk failure. Sample E and Sample F showed different amounts of drop in optical output

power. Sample E with a ~60% drop in optical power and Sample F with an ~100% drop. All unpassivated broad-area lasers studied for this investigation failed by COMD, and none of these devices showed bulk failure. In contrast, ~30% of the passivated broad-area lasers tested showed bulk failure, indicating that good passivation increases the threshold for COMD so that it may become larger than the threshold for bulk failure. In addition, all single-mode lasers we previously investigated failed by COMD.

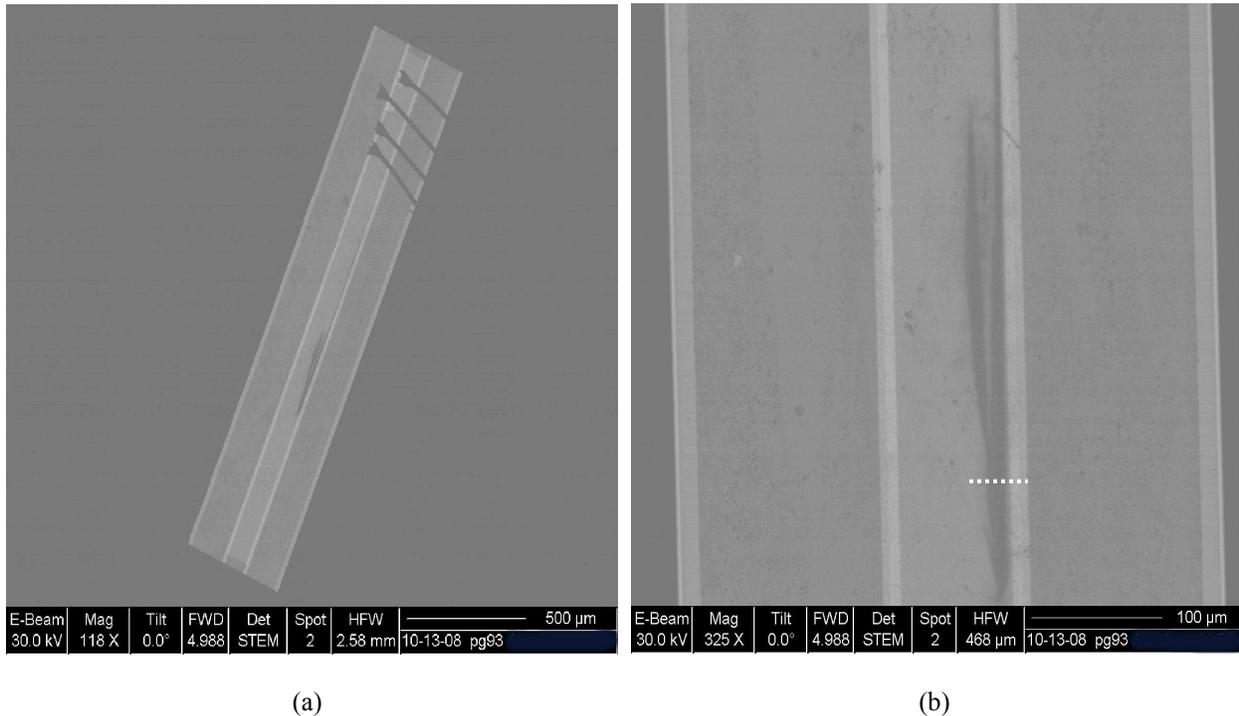
Figure 8. EBIC images showing the whole chip (a) and DLD area (b) of Sample G.

Figure 8 shows EBIC images showing the whole chip (a) and front facet area (b) of Sample G, which showed a ~25% drop in optical power. This sample also degraded by bulk failure. Compared to Sample E and Sample G,

Sample F showed significant bulk damage. It is interesting to note that the three bulk failures (Sample E, Sample F, and Sample G) show a good correlation between amounts of drop in optical power and DLD areas.

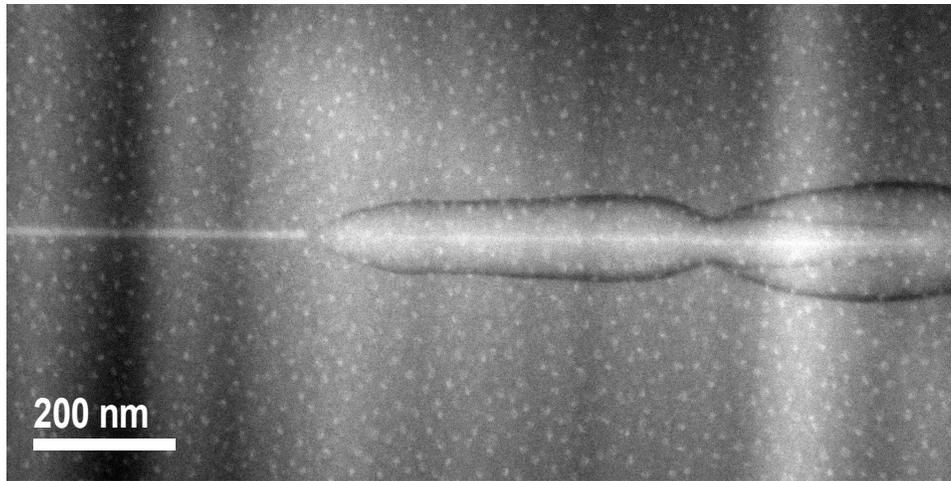
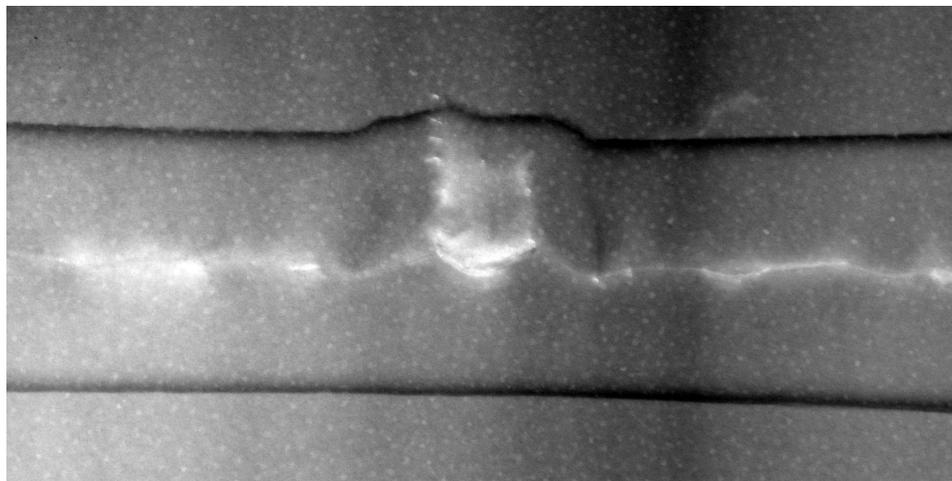
Figure 9. Cross sectional TEM images of Sample G (a, b).

To understand the failure mechanisms responsible for catastrophic bulk degradation of broad-area lasers, a series of TEM samples were prepared from bulk failures using focused ion beam analysis. Figure 9 show TEM images from Sample G. The EBIC image of Sample G is shown in Figure 8 (b), where the location of the TEM sample is shown as a dotted line. The TEM sample was located ~600μm away from the front facet and enclosed the dark line. The TEM image clearly shows a high density of dislocations well confined in the vicinity of the InGaAs quantum well. Detailed TEM analysis is in progress to compare bulk failures with facet failures.
